**DEPARTMENT OF TRANSPORTATION**

Contract #: 04-0120F4Cty: SF/ALA Rte: 80 PM: 13.2/13.9File #: 69.28**WELDING INSPECTION REPORT****Resident Engineer:**Siegenthaler, Peter**Address:** 333 Burma Road**City:** Oakland, CA 94607**Report No:** WIR-022087**Date Inspected:** 12-Jan-2011**Project Name:** SAS Superstructure**OSM Arrival Time:** 700**Prime Contractor:** American Bridge/Fluor Enterprises, a JV**OSM Departure Time:** 1900**Contractor:** Zhenhua Port Machinery Company, Ltd (ZPMC), Changxing Island **Location:** Shanghai, China**CWI Name:** An Qing Xiang, Qiu Wen**CWI Present:** Yes No**Inspected CWI report:** Yes No N/A**Rod Oven in Use:** Yes No N/A**Electrode to specification:** Yes No N/A**Weld Procedures Followed:** Yes No N/A**Qualified Welders:** Yes No N/A**Verified Joint Fit-up:** Yes No N/A**Approved Drawings:** Yes No N/A**Approved WPS:** Yes No N/A**Delayed / Cancelled:** Yes No N/A**Bridge No:** 34-0006**Component:** OBG**Summary of Items Observed:**

BAY 14, OBG 13AW (NWIT # 08150)

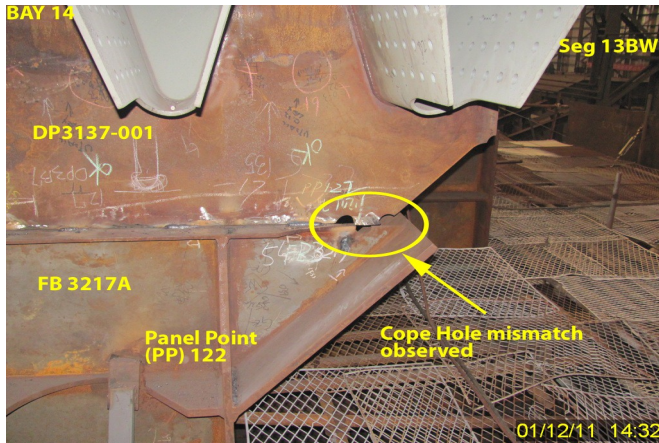
During random in process inspection this QA inspector observed that the cope hole observed as misaligned from original locations. The parts joining deck panel diaphragm plate of deck panel (DP) 3137 to flange of Floor Beam (FB) 3317 at Panel Point (PP) 122. This issue has been discussed with ZPMC CWI Mr. Qiu Wen and CT lead QA. Mr. Qiu Wen informed this QA that this issue would be corrected in manner comply with contract documents. Attached photograph provide additional details.

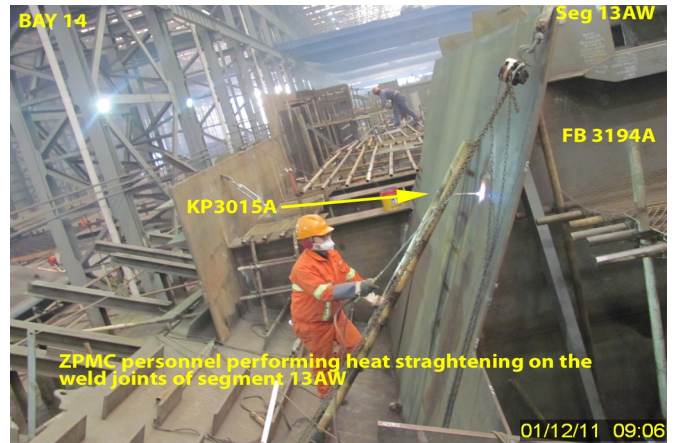
ZPMC personnel heat straightening Orthotropic Box Girder (OBG) member identified as the weld joints of segment 13AW joining K Plate (KP) 3015A to Floor Beam (FB) 3194A at Panel Point (PP) 119.65. Distortion appeared to be caused by welding of the material. ZPMC Quality Control (QC) inspector identified as Mr. Liu Fang was present to monitor the heat straightening process. The heat straightening appeared to comply with Heat Straightening Report (HSR) number 10061. Attached photograph provides additional details.
